Axle Failures Revisited

by Tom Norman

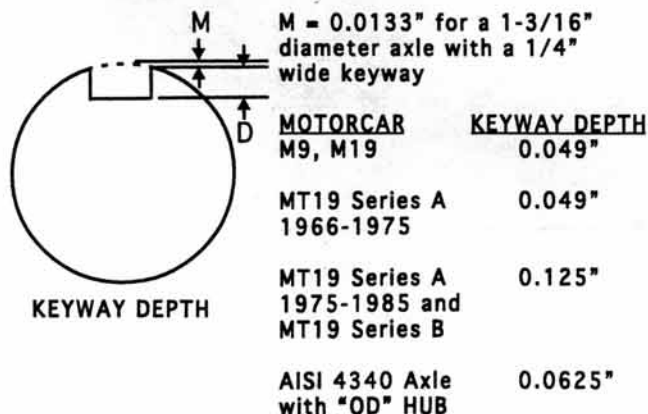
By this time I had observed 7 axle failures on MT19 Series A and B motorcars. All the axles broke in a plane perpendicular to the shaft center line at the keyway, usually in line with the sprocket. The shafts were AISI 1045 steel, with a tensile strength of 90,000 psi. These axles are 1-3/16" in diameter, same as on M9 and M19s. Why axle failures on MT19s only? Engine horsepower and torque at the rear axle is higher on MT19s, but still within design limits for the AISI 1045 steel. The other obvious difference is belt drive verses chain drive. The design change for the Onan engine and chain drive required a relocation of the center bearing to 6-1/4" to the right of the car centerline, as opposed to 1-1/4" on the belt cars. This put the sprocket and keyway much closer to the center bearing. On a belt car the centerline of the pulley and center bearing are 5-1/2" apart, while the distance between the sprocket and center bearing centerline is only 1-3/4". Unidirectional bending fatigue suggests the maximum stress is at the center bearing, but the weakest part of the axle is the keyway, and the keyway is substantially closer to the center bearing on the MT19 than on a belt car. The biggest change between the M9/M19 axle and the MT19 is in the keyway depth. The keyway depth (see drawing below) on M9/M19s is 0.049". Initially this depth was used on MT19's when the car was introduced in 1966. However around 1975 this depth was increased to 0.125". I believe this change was due to sprocket hub problems. The original sprocket hub was secured by set screws. If these set screws loosened, the hub rocked back and forth on the axle until the keyway was wallowed out. I believe Fairmont went to the deeper keyway to prevent this problem, but kept the old style hub. Apparently this did not cure the problem as they changed to the "QD" tapered hub by 1985. This solved the loose hub problem but I believe that retaining the deep keyway in the axle contributes to axle failures.

Consolidating this information, my solution for a new axle was to machine one using AISI 4340 steel hardened to 38 to 40 Rc. I also cut the keyway to a depth of 0.0625", half the depth of the old axle, and much closer to the M9/M19 axle at 0.049". The 0.0625" depth allowed me to utilize 3/16" by 1/4" keystock to make the new key, while retaining the QD hub originally machined for a 1/4" square key. I'm not worried about this keyway depth, especially with the QD taper lock type hub. M19AAs with the twin cylinder Fairmont engine use the shallower 0.049" keyway depth, same as other M19s. The maximum torque at the rear axle for the RKB twin is 106.8 ft-lbs, not that far from the Onan B48G of 128.9 ft-lbs.
