Fairmont "Weatherseald" Timer Block

A BAD GROUND COULD CAUSE IGNITION PROBLEMS

**By Harry Riblett
Fairmont M19-F No. 201015**

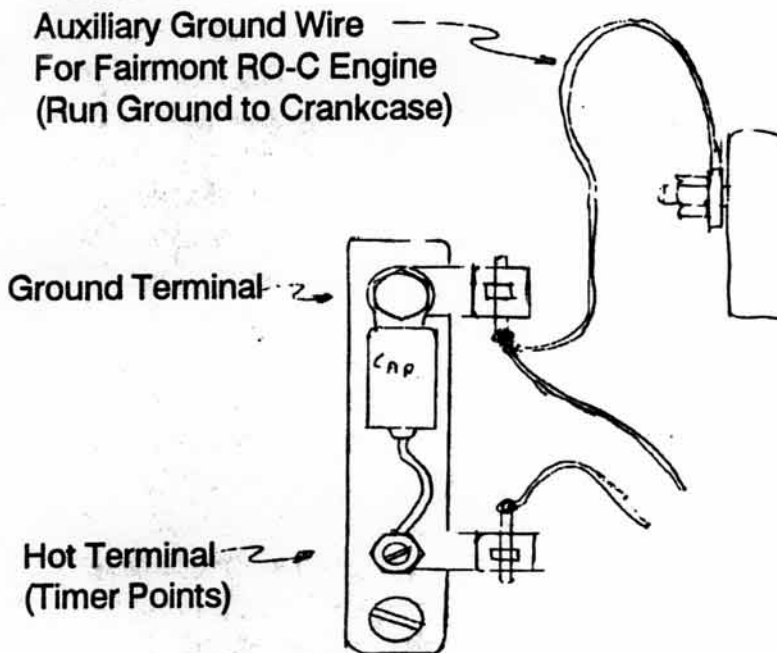
After struggling with a nagging ignition problem on my Fairmont M19 RO-C engine for over two years, I finally found the problem, which I'm happy to pass along to fellow NARCOA members.

Due to the design of the timer block, the ground circuit to the engine is not reliable. Accordingly, I added an auxiliary ground wire from the ground terminal on the timer block to the closest stud on the crankcase, and this now provides a reliable ground. The wire should be long enough to have a sizeable loop in it, since it flexes when the timer lever is moved. What a difference it makes!
