# A-4-E RAIL SKIDS

## THE HIDDEN WHEEL ALIGNMENT PROBLEM

BY JERRY HIXSON

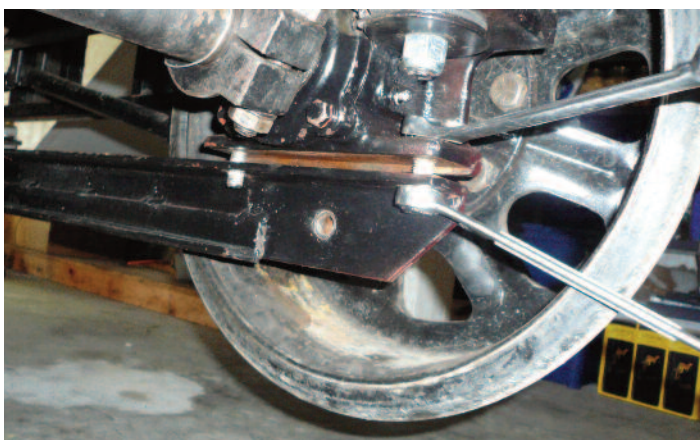
Fairmont A4E gang car rail skids bolt directly onto the wheel bearing housings (above left) and have a center support point (arrow above right). Jerry Hixson from Carlton, WA, traced his wheel alignment problem to bent rail skids. Either through poor heat management during manufacturing, or heavy use by the railroad, his rail skids were bent (below left). Although his frame was square, the bend in the skids caused his wheels to be out of alignment. Hixson made new skids (below right) - solving the problem.

However, looking along the skid rail a gentle bend was apparent. It was most likely from the welding process of making a channel out of two angle pieces. Checking with the other A4E owners they said theirs were that way also, giving the front and rear a very slight tow-out. Now with all the support cross-members, brackets, and axle bearing mounts, it was really hard to tell how badly the skid frame was bent or twisted.
