B48G CLUTCH OVERHAUL

BY WAYNE PARSONS

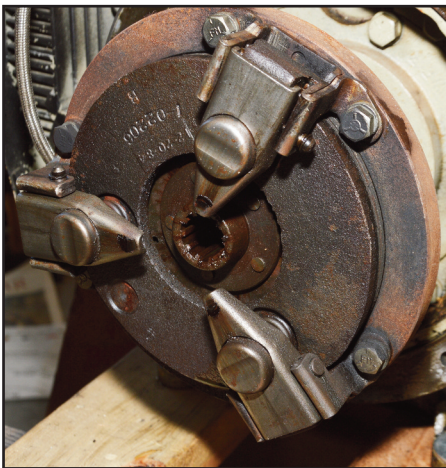
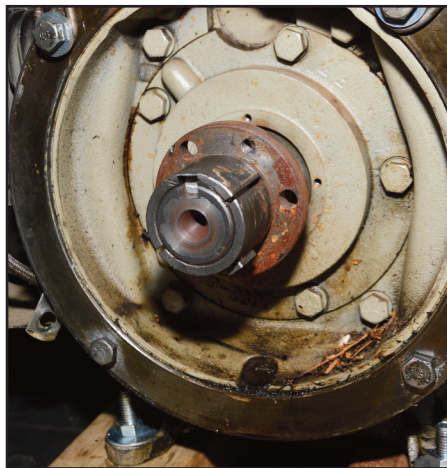
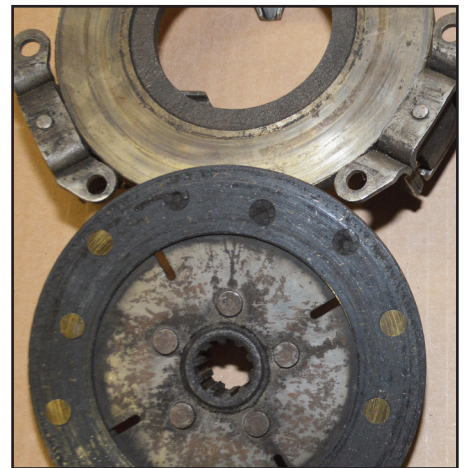
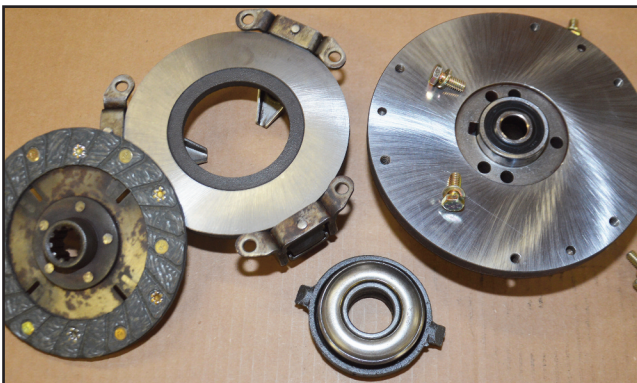
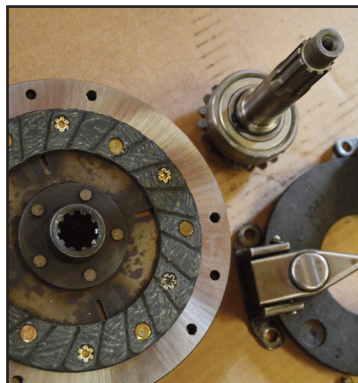
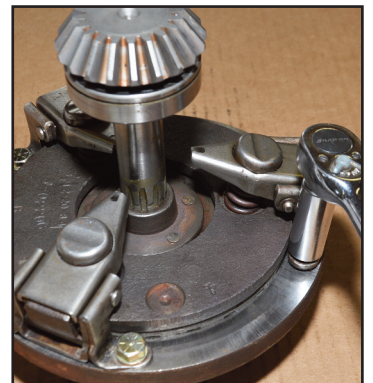
Before starting, take some pictures for reference. Lift out the motor and transmission as one unit. *Center below left:* The driven plate, between the pressure plate and flywheel, is covered with oil. Oil has leaked out of the transmission and along the bevel pinion. The driven plate material can't get a grip now because of wear and the oil. *Below center:* With the clutch removed the back of the motor is exposed. Check for leaks and clean the area. Leave the bushing assembly on the crankshaft. *Center right:* The worn pressure plate (top) and driven plate. *Below left:* The clutch is back from the shop with newly machined surfaces and new friction material. A new 6303-2RS bearing will be pressed into the flywheel center and a new throwout bearing used. *Below right:* Use the bevel pinion to line up the driven plate while inserting and tightening down the pressure plate bolts.

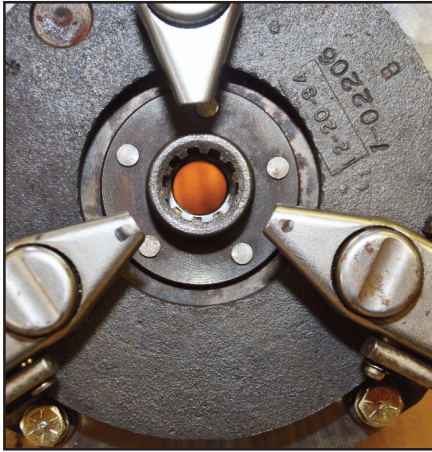
After removing the bevel pinion, the center of the driven plate lines up perfectly with the bearing. This is important for mating back up the transmission with the motor.

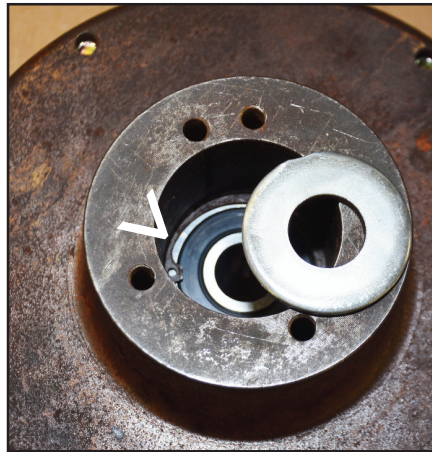
Note the retaining ring that determines the bearing position. The retaining ring is also the stop for the wrought washer against which the bushing assembly tightens down.

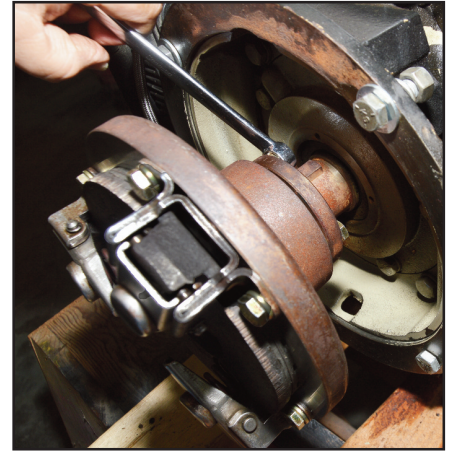
Three bolts hold the clutch on the bushing assembly. Tighten down snugly while remembering that the wrought washer is pushing against the retaining ring.

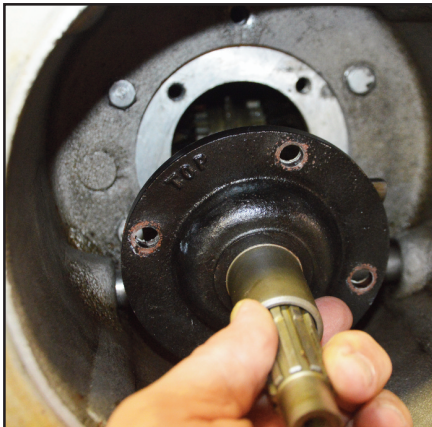
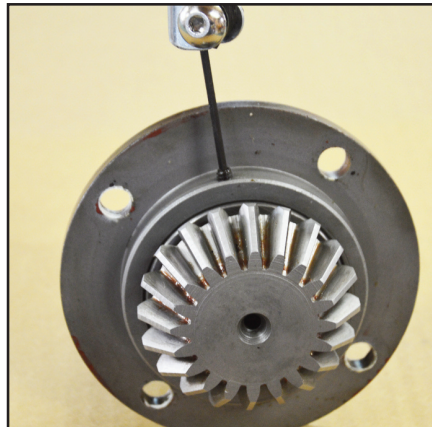
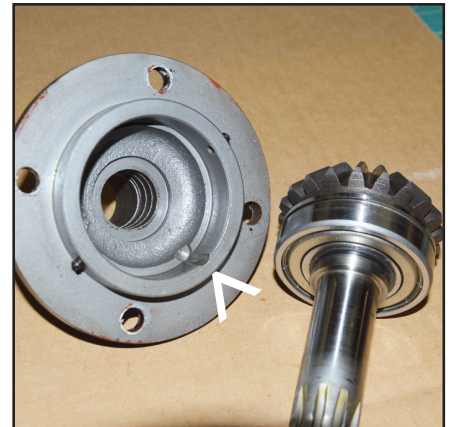
The bevel pinion wiggled indicating that the 6206-RSNR bearing on the shaft was worn. The pinion carrier assembly is easily removed from the bell housing by sliding the clutch release yoke left and right to loosen the four bolts. To release the bevel pinion, unscrew the two socket hex head cone point set screws. A local transmission shop pulled the bearing and pressed a new one on. Note the weep hole at the inside bottom of the pinion carrier. Oil that gets past the bearing is meant to drain back into the transmission sump. To reduce oil escaping out the weep hole, don't over fill the transmission and use straight 140 weight gear oil.
