LES KING TURNTABLE FAILURE

BY JOHN GONDER

LES KING TURNTABLE SOLUTIONS

BY JIM MOREFIELD

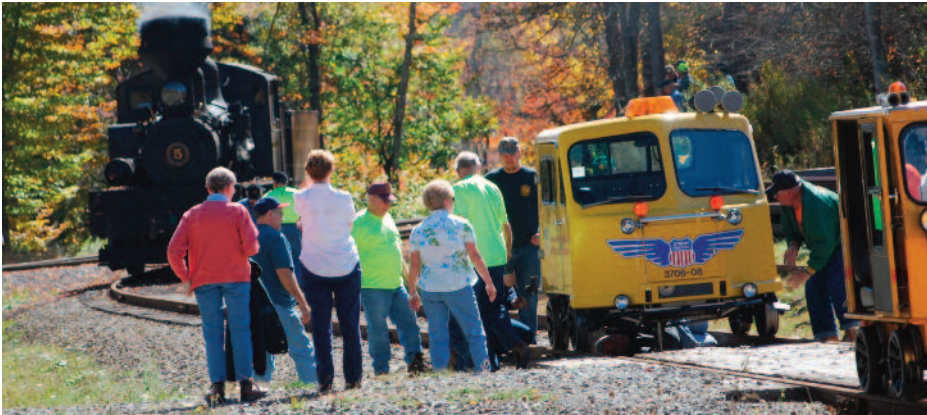
John Gonder's turntable has just fallen apart while turning his Woodings motorcar Oct. 11, 2008, at Old Spruce on the West Virginia Central Railroad.

Things were fine until I turned the car at our turnaround spot. The car didn't seem to lift correctly. The motor on the table labored and moved very slowly. It did lift the car and we did turn it around. When I retracted the table it went up about half way, and then with a loud clank, the entire inside shaft of the jack and the plate, along with all the bearings and spacers, fell to the ties. This could have been deadly had it happened while moving.

"clicks" and slips at the end of the stroke travel of the jack hadn't been working for a while. I would just lift the jack until it stopped, and that seemed to work fine. The clutch was the culprit that caused damage to the rest of the jack.

Inside the jack at the top of the tube, between the motor and the jack shaft, is a drive coupler nut with a slot in it. The drive shaft on the motor has a pin through it that matches up with the slot and drives the shaft up or down. When the jack lifts the car, the motor and shaft rotate clockwise. This tightens the nut on the threads. However, when you retract the table, all this turns counter-clockwise, and when the end of travel is reached, the nut can spin off the threads, just as it did here.

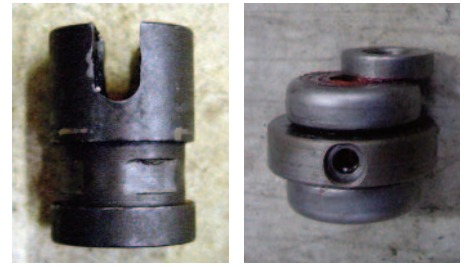
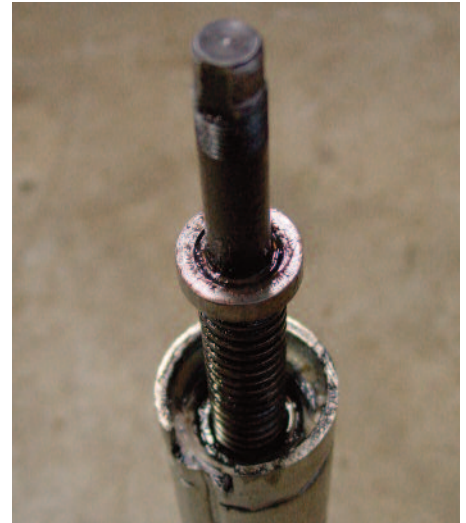
The drive coupler nut is squeezed onto the shaft at the factory to keep it from coming off the threads, but the motor has enough torque to spin it off easily if the clutch doesn't work. When the drive coupler nut comes off there is nothing at all to stop the entire bottom half of the jack from falling completely out of the car. After talking with the manufacturer of the jack, it was determined that the failure was a direct result of running the table up until I heard the clutch "click," because that is what I thought we were supposed to do. The manufacturer says no. The clutch is not to be used except in emergencies.

The bearing assembly (top right) sits on the threaded actuator shaft (above) and is held in place by the drive coupler nut (top left). If the drive coupler nut should back totally off, the entire turntable will fall and cause a moving motorcar to crash forward onto its nose.

I replaced the clutch and the gear that contains it along with a new drive coupler nut. If your table goes up and stops, but does not slip, it is urgent that you replace the clutch. Dean Mark at Fredericksburg Shops has the replacement parts in stock. The part numbers for the clutch are:

Torque Limiter and base casting (must be purchased together as an upgrade) 30476 and the drive coupler nut is 11537. All are easily replaced. The new gear is metal instead of plastic. While you have the motor head off the jack, inspect the drive coupler nut to make sure it is threaded all the way down against the spacer and bearing assembly.

I suggest that when reinstalling the drive coupler nut, you drill and pin it to eliminate any chance of this happening (see photo 3 on page 12). Also check the motor housing at the set screws where it fits over the jack. Tightening the set screws too tight will split the casting along the bolsters for the set screws.

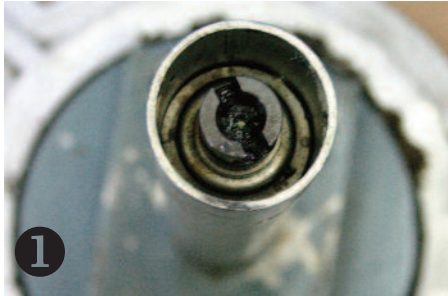
The latest concerns about the Les King Turntables involve the slotted drive coupler nut on the top of the actuator shaft (above), and the security of the actuator shaft provided by three Allen head setscrews (below) countersunk into the outer tube .

I feel the most likely part to fail is the slotted drive coupler nut at the top of the actuator shaft (photos 1 & 3) and one reported failure indicated this nut worked off the shaft and allowed the assembly to drop while it was being tested off track. It appears after the nut is tightened on the top of the shaft, the threads are deformed to prevent the nut from backing off. The modification discussed in this case was to either weld the slotted drive coupler nut to the top of the actuator shaft or drill the nut and shaft and insert a pin (photo 3).

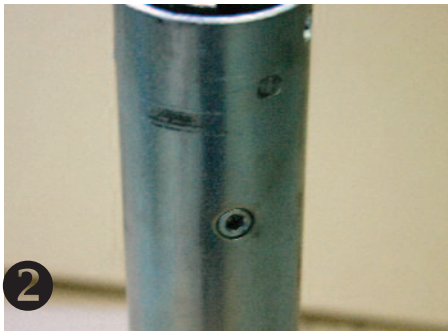
In my opinion, it’s not likely that the set screws holding the assembly via the top guide will all back out without a competent operator noticing it. A quick inspection of the assembly (photo 2) can be made any time the tunnel cover is off. Depending on the material used for the actuator nut in the inner tube, it could begin to work inside the tube and wear enough to allow it to pass the crimp in the tube or it might tend to spin inside the tube. Turning inside the tube is unlikely as the slot in the tube fits in a depression of the actuator nut. If by some chance it did begin to turn, the turntable motor would run, but the turntable base would not move. It doesn’t

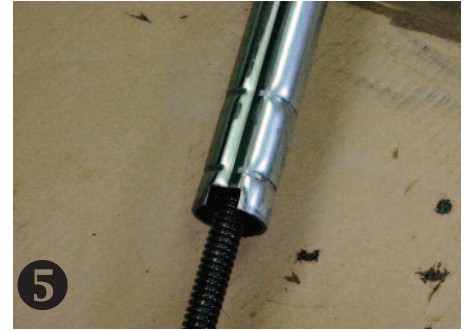
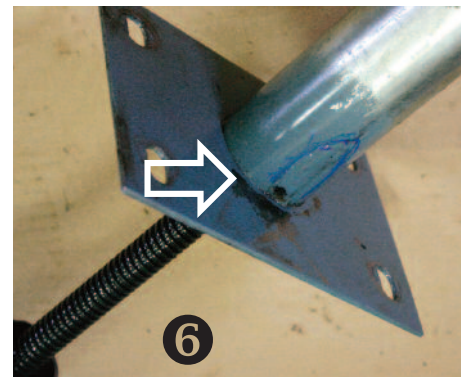
The actuator nut in the inner tube is crimped in place. The inner tube has a slot the entire length (above) that matches up with a “dimple” at the bottom of the outer tube (below) to prevent the inner assembly from rotating. The dimple is filled with weld on the outside of the tube (arrow).

appear the crimp will wear out and due to the length of the actuator nut, again in my opinion, it is unlikely this will fail without giving an indication something is amiss.

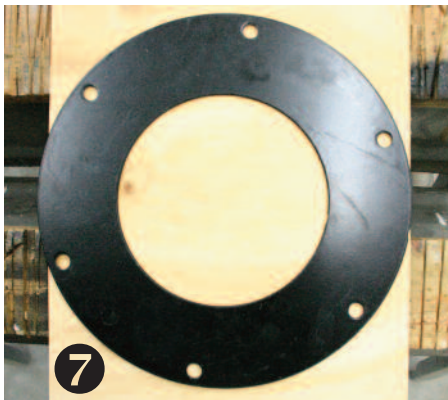
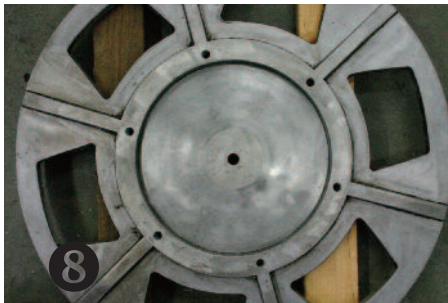
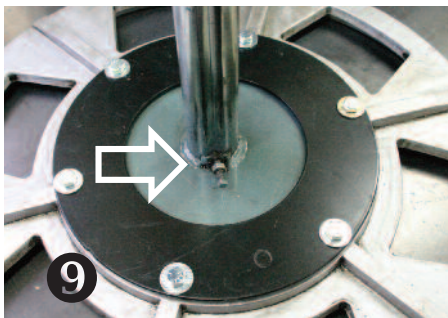
Top: Hole pattern for plate with a 6 1/4" center hole in a 11 1/4" diameter 1/8" plate. **Center:** Corresponding hole pattern in the base. **Bottom:** completed assembly is much stronger than the original single bolt (arrow).

Until recently, the bases on electric turntables were attached to the bottom of the jack mechanism by a single bolt held in place with a set screw (photo 9 arrow). This was necessary to allow the motorcar to rotate on the base while turning the car. Several operators noted the bolt would back out and in one instance, the base fell off while the operator was hauling his car on a trailer.

Rod Whitney came up with good solution for this situation. He cut a quarter inch aluminum plate 11.5" in diameter with a 7" hole in the center that would slide over the mounting plate of the jack, but was smaller than the base of the jack. He drilled holes in the turntable base (photo 8) and attached the plate to the base. He left the center bolt in place to keep the base centered, but if the bolt should back out, the safety plate will hold the base in place.

The new turntables now available have safety plates (photo 7) constructed of 1/8" steel plate 11-1/4" in diameter with a 6-1/4" hole in the center and attach the same way. Instead of a bolt in the center of the base, a stud is used solely for centering purposes and the plate holds the base in place.

The side of the bowl in the base on older models is low enough that the plate must be shimmed to allow the base to rotate freely. Newer models have higher sides on the bowl and don't need to be shimmed. I would recommend a minimum 1/8" gap between the plate and jack mechanism (photo 9).

The three photos at left show the hole patterns for the safety plate and turntable base, and what it looks like after inserting the bolts in from the top to check clearances. Once satisfied I had the clearance I wanted, I used 3/8 x 2-1/4" bolts with washers on both ends inserted from the bottom of the base and secured with nylock nuts.

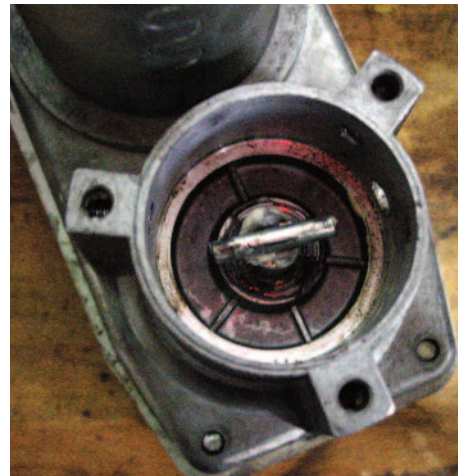
The drive shaft on the motor has a pin through it that matches up with the slot and drives the shaft up or down.
