Accidents Waiting to Happen?

by Tom Norman

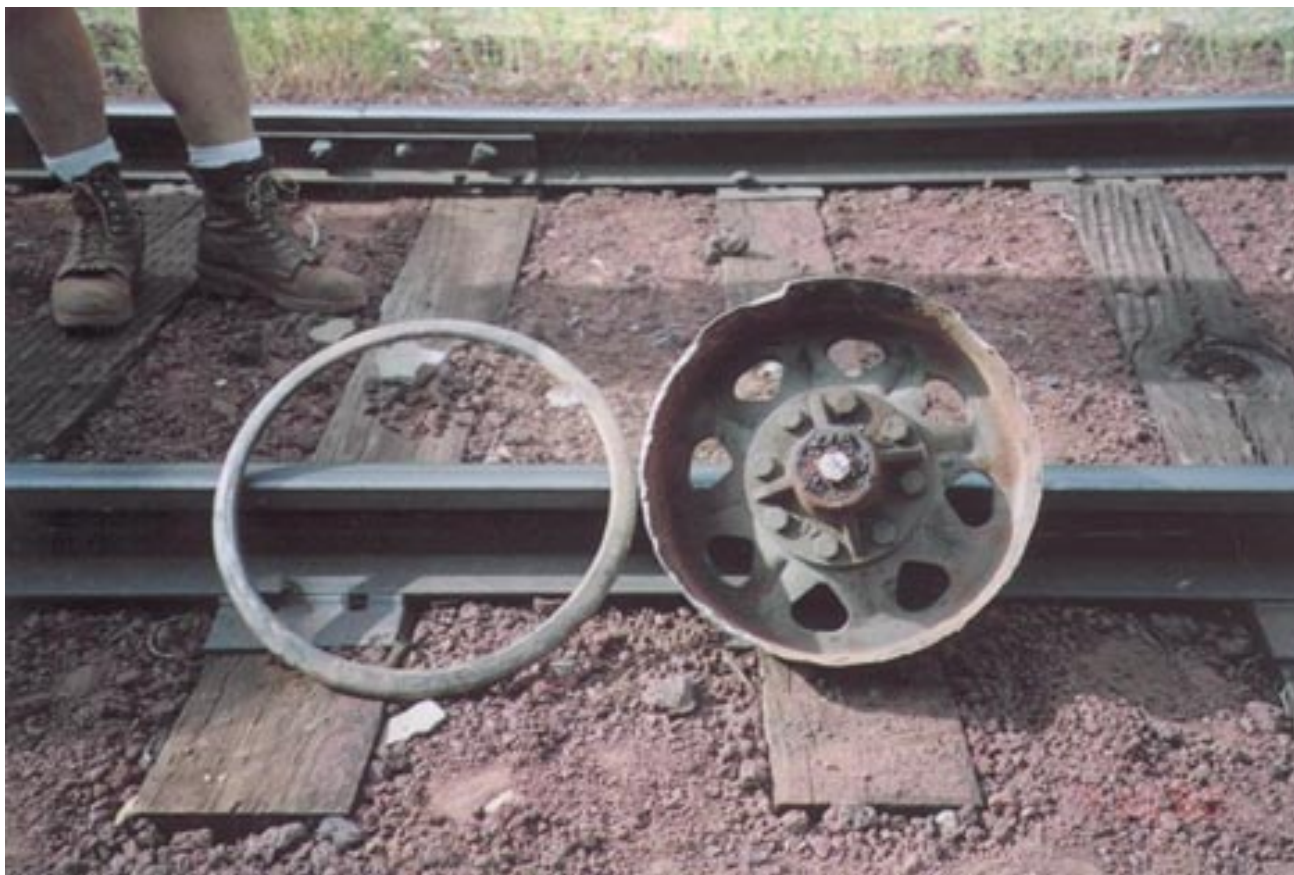
The first incident involved a motorcar in which the flange or rim of the wheel separated from the wheel tread. The resulting derailment also caused the axle to break at the wheel bearing, as can be seen in the attached photo.

Flange separation from 16" demountable wheel due to flange wear.

This is not the first incident of flange separation that I've observed. The basic reason for failure is excessive wear of the wheel. Generally, wheel running surface thickness should not be less than half the original wheel thickness. New 16" demountable wheels today are 5/16" thick, and should be replaced when worn to 5/32". At car inspections before excursions, most inspectors will have a wheel thickness gauge available to check for wheel wear. A gauge is available from Harbor Freight Tools (www.harborfreight.com), item #38238, caliper measuring tool for \$3.99 plus s&h. From my experience, wheel wear occurs mainly at the flange/tread interface, not on the tread itself. I have sectioned three 16" wheels to help illustrate this wear. In the following photo, the top section is a relatively new wheel, showing good thickness throughout. The middle section is from my MT19B after 11,027 miles on new 5/16" wheels. Note that the thickness at the flange/tread interface is just over 1/8". The bottom section is from my Kalamazoo 27A, showing severe wear exceeding the NARCOA rulebook limits. Note that the tread thickness shows negligible wear even on the Kalamazoo wheel. Compare the worn wheel section profiles with the wheel profile drawing. It is easy to see the wear. It shows as a "squaring" of the flange rather than the smooth curves of the original profile.

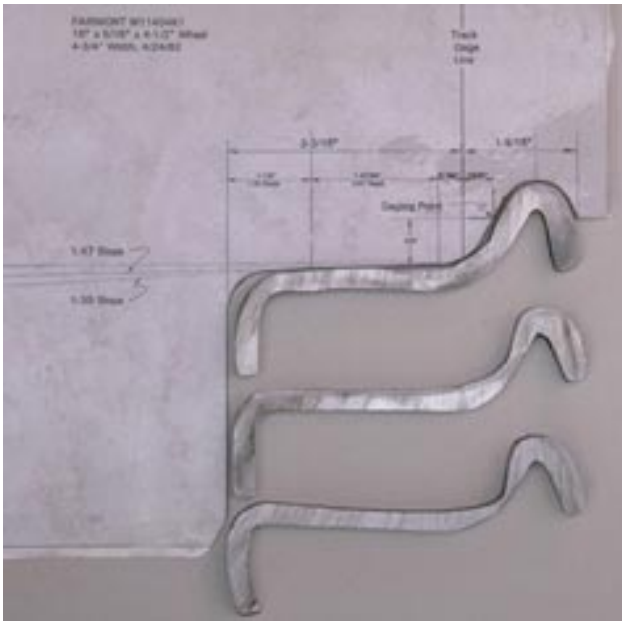
Wheel profile drawing and cross sections of 16" demountable wheels. Note flange wear on bottom two sections.

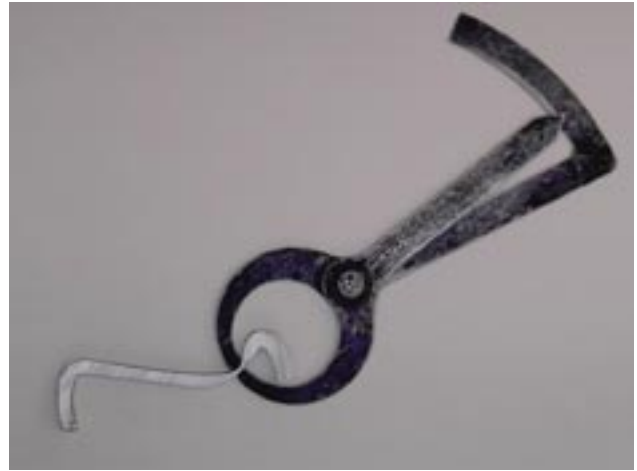
Method of measuring flange/tread interface with wheel thickness gauge.

The lesson here is that wheel thickness should also be measured at the flange/tread interface as illustrated in this photo. Several things can give a false thickness reading. Any mastic or sound proof coating applied to the wheel will give a false reading. Fairmont wheels with these coatings normally have a small portion left bare for thickness measurement. Measure at those locations. Some wheels have a rubber hose stuffed in the flange for sound deadening. Remove the hose then take the thickness reading. If you find any wheel thickness readings less than 1/8", replace them before your next excursion.

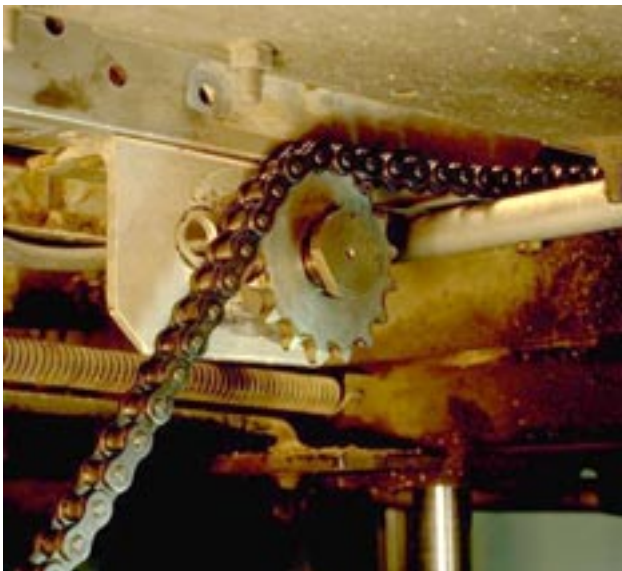
Another accident waiting to happen involves the brake shafts on MT14 and MT19 chain-drive cars. The brake shaft is made from 7/8" OD steel tubing with a 1/16" wall. The drive chain is guided up and over the brake shaft by the idler sprocket. Poor maintenance, excessive chain slack, and/or elongation of the chain due to wear, allows the chain to rub on the brake shaft. See the following photo. We have had

MT19 chain path showing chain slack, which can lead to brake shaft wear and failure.

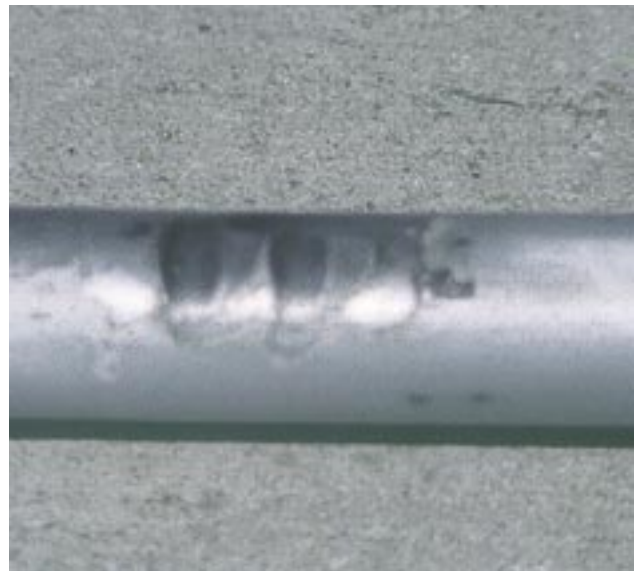
Brake shaft worn nearly half way through. Note twist and bend in shaft from brake application.
