FIX THAT OIL LEAK!

Compiled by Bud Stych

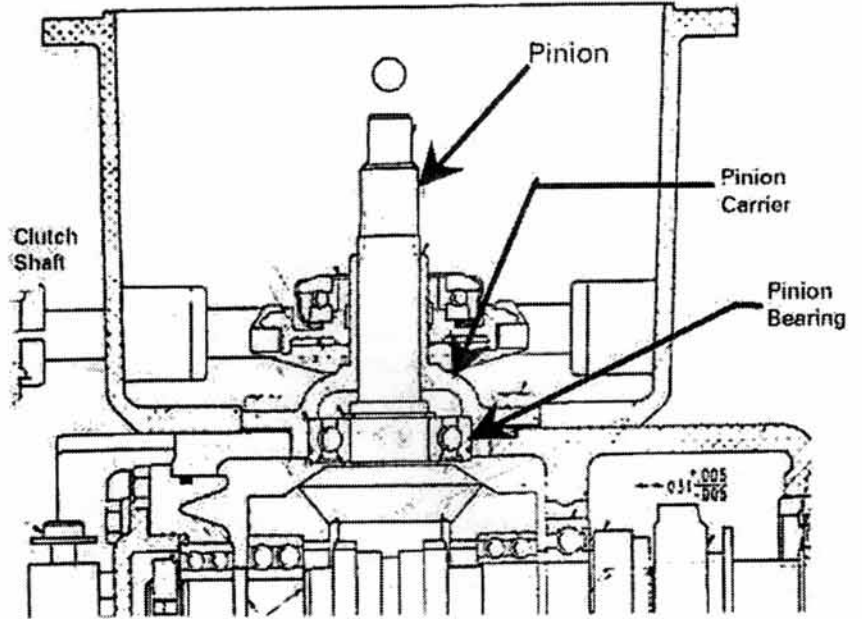
Section of Clutch Housing, viewed from above.

This is the information on adding an additional seal to the Transmission Input Shaft on an MT19A or MT14. Possibly just replacing the pinion bearing with a new sealed bearing will do the job, but installing the CR9244 seal while the transmission is on the bench gives additional insurance. If you find any incorrect information or have suggestions, please send them to me. Also, I want to know if this solution worked for you.

1. A replacement pinion bearing.
Tom Norman suggests using MRC #206SZZG which has a double seal, and prying out the inner seal to allow the oil to lubricate the bearing.
 2. A CR9244 seal from your local bearing supplier.
- A. Drain transmission fluid, remove transmission and clutch housing from the motor and separate them. Flush transmission.
 - B. Remove pinion and pinion carrier.
 - C. Remove pinion bearing retaining ring and pinion bearing.
 - D. Charlie Jensen suggests filing a small V-notch (perhaps angled downward towards the transmission) in the bottom of the hole where the bearing is mounted to allow the lubricant to drain back into the transmission.
 - E. Replace pinion bearing with replacement bearing.
 - F. Replace pinion bearing retaining ring.
 - G. Have a 3/16" deep hole bored in pinion carrier to accept CR9244 seal.

(Get the diameter from the bearing supplier. My supplier says 1.375").

- H. Have the CR9244 seal inserted in the bored hole with the open end of the seal towards the transmission (seal will protrude some).
- I. Polish the pinion shaft area where the CR9244 seal will ride on it.
- J. Replace pinion carrier. Use RTV seal around the pinion carrier bolt threads to prevent oil from wicking out.
- K. Bolt 'er up, fill 'er up, and get back on the rails.

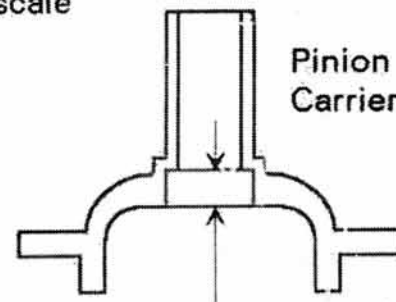
Bore Hole
 3/16" deep
 for seal
