FAIRMONT TRANSMISSION VENT VS. DIPSTICK

BY ED LEE

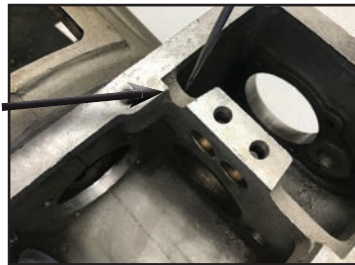
The vent for a Fairmont transmission is located in the aluminum top cover. The purpose of the vent is to exhaust any positive pressure that may be created by the normal motion of the oil in the transmission or any heat created during normal operation. The top cover is held on with six (6) symmetrically spaced 3/6" X 16 bolts. When the vent is in the correct position, it is located over a cavity in the inner support wall in the transmission. This cavity shields the vent from any direct spray of oil that may be thrown from the moving parts.

Fig. I Arrow indicates cavity

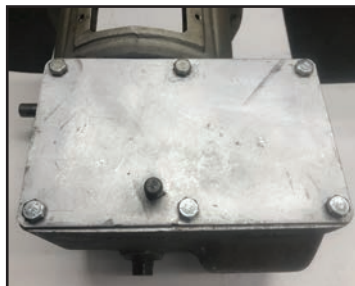
When the aluminum top cover is installed incorrectly the vent is near the opposite end of the transmission. In the incorrect location there is no cavity to shield the vent from spray oil, causing the oil to leak out of the vent.

Fig. III Incorrect orientation

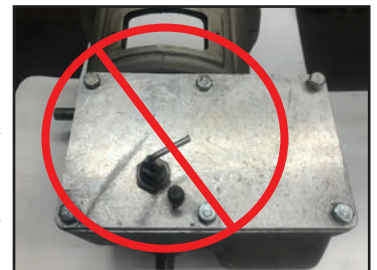
The dipstick in Fig. V was installed with the vent in the wrong location and made it impossible to install the top with the vent in the correct location.

Fig. V The vent will leak from this ruined cover.

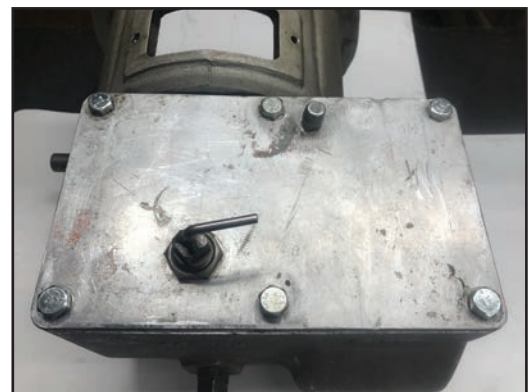
This transmission has both the vent and dipstick in the correct locations. The vent will function as designed as will the dipstick

The correct location for the dipstick is a point that is 3" from the left side (shift lever side) of the transmission and 1 3/4" from the rear of the transmission. This is the only location that will have clearance from the moving parts. (Fig. IV)
