Additions to Brake Adjustment Article

By Dick Ray
WM M9 #67

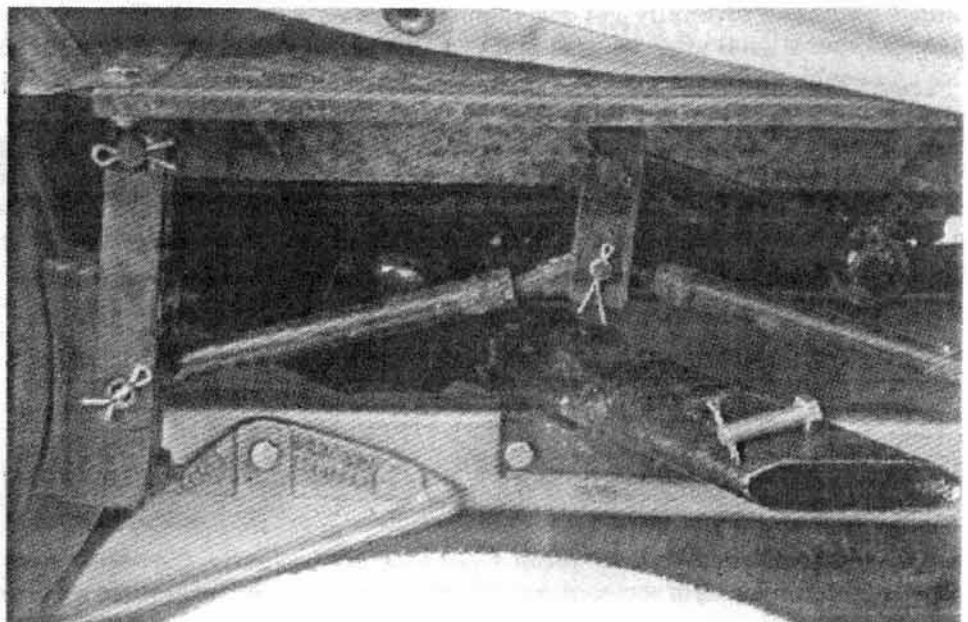
get a stainless bolt of the proper diameter that has at least 1.5 inches of unthreaded stock next to the head. Then saw off all the threaded portion, drill a hole for the cotter pin at the right point, and insert the bolt from the back, securing it with a stainless cotter pin. Since it does not rust the bolt makes a pivot which can function freely with little or no lubrication. The photo shows all cotter pins on the outside and a brake pin made from a bolt.

Another brake-related issue has come up, and it relates to the cotter pins in the tube on which the shoe pivots. The drawing with the previous article on brake adjustment (or the one in your manual) shows the cotter pin on the outside. This makes sense, so that the condition of the cotter can be inspected. A lot of cars out there, however, have the cotter on the inside. While some might have done it for neatness, I suspect it just came out that way the last time the brakes were overhauled. Although cotteners on the inside work as well on most cars, there can be a problem with MT14 and larger cars which use a wider brake liner. The cotter pin can rotate so that one end can contact the edge of the brake shoe. That causes a short across the insulation when the brakes are applied and can set off signals. If it is on the inside, this flaw cannot be seen and causes a lot of head scratching when the signals come on. The solution is to put the cotter pins on the outside where they can be seen. Then bend the legs of the cotteners so that they cannot possibly touch the shoes.

For those who like to go to the ultimate in appearance as well as safety, I suggest stainless steel cotter pins. They are easy enough to obtain, never rust, and are always shiny. The pins with a cotter on each end that go through the vertical links can be replaced with stainless also. Simply
