Check the Drawbar on Your Motorcar Trailer

By Mike Paul

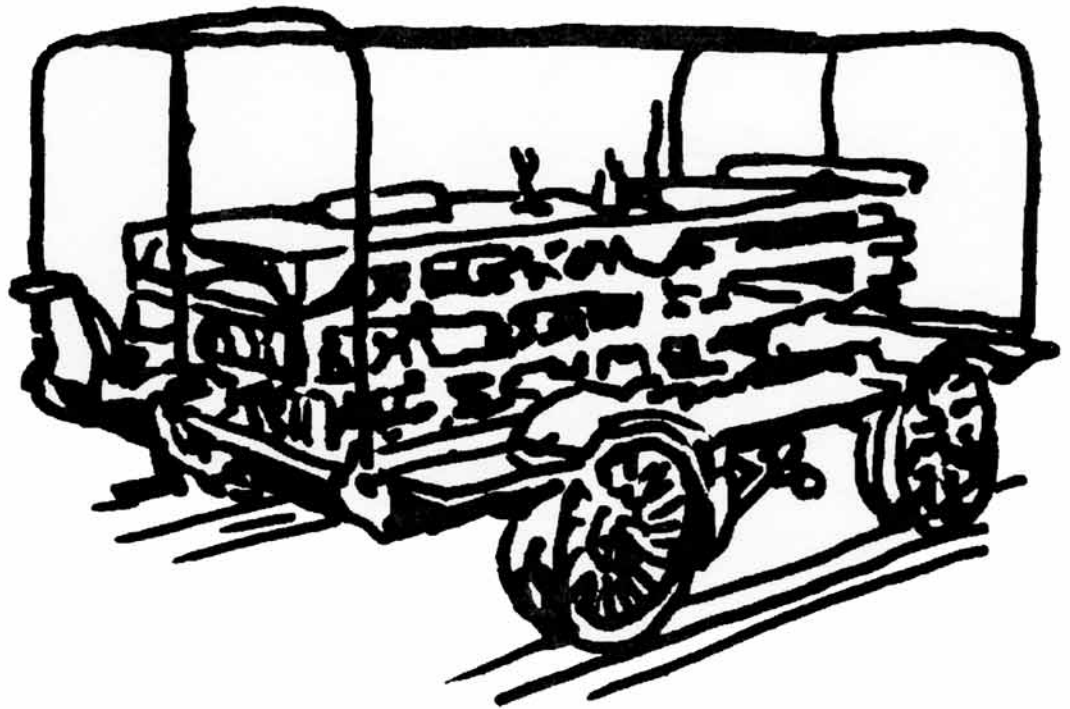
On that date, while traveling down the highway at 55 m.p.h. with my M19 aboard the trailer, the drawbar collapsed at one of the formed bends, and the bent drawbar scraped along the highway until I was able to slow down and bring my rig to a stop on the shoulder. After appraising the damage, I then attempted to drive the disabled trailer off the highway shoulder into a roadside business, and in so doing, the drawbar completely broke in half, leaving a three-foot-long section of the drawbar attached to my tow vehicle and the rest of the trailer sitting forlornly, nose down in the gravel yard of the roadside business.

I am therefore advising all owners of the Chilton model UT6020S-1 tilt-bed trailer to carefully check their trailer drawbars at the two formed bends for evidence of cracking, particularly on the undersides of those bends. If cracks are noted, the drawbar should be replaced immediately to avoid the situation I encountered. If you doubt

your ability to determine if the drawbar is cracked, your professional weld shop should be willing to appraise this situation for you. I asked Chilton to gusset the two bend areas on the new drawbar and they graciously complied.

If you are concerned about the integrity of your drawbar, even though cracks are not evident, you might ask an experienced, professional welder to put gussets on both sides of the formed bend areas to increase the drawbar strength. If you elect to have this done, be sure that your welder is competent. The drawbar is a thin-wall tube and if welding is not done properly, the drawbar may be weakened rather than strengthened if gusseted improperly.
