FAIRMONT MOTORCAR BRAKES AND BRAKE ASSEMBLIES

BY PERRY R. FRYE

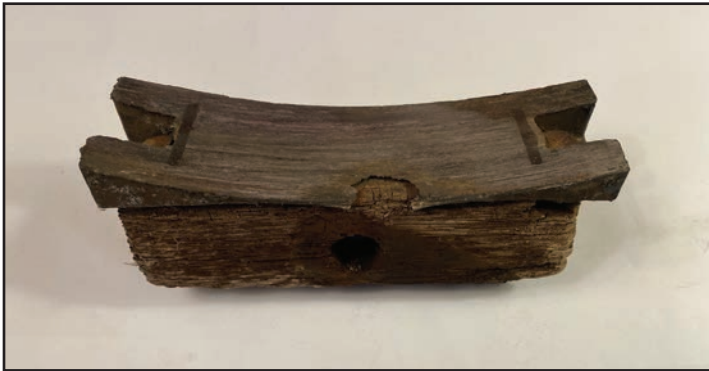
This brake block and liner have reached the end of their useful life and should be replaced

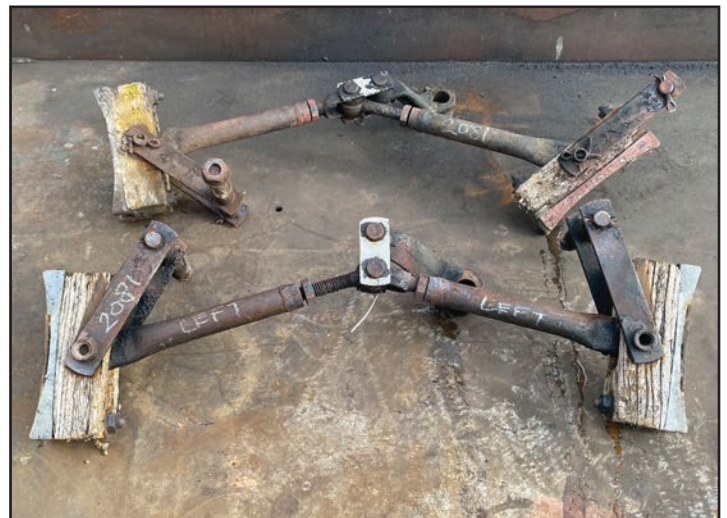
An example of a heavily corroded Fairmont M-19 brake assembly in need of rehabilitation

A best practice is to snap a picture before disassembly of the brake riggings to assure correct reassembly. If a brake assembly is significantly corroded and rehabilitation is needed, I have found it easiest to remove the entire assembly by pulling the cotter pins from the front and rear pivot studs, and the cotter pin from the upper toggle link pin. Once the rigging is removed, apply liberal amounts of your favorite penetrating oil to threads and joints. Most parts should

disassemble within a few hours. Care should be taken when loosening the jam nuts on the assembly as they are narrow and can easily be stripped if the end wrench is not engaged correctly. Heavy corrosion makes this process more difficult.

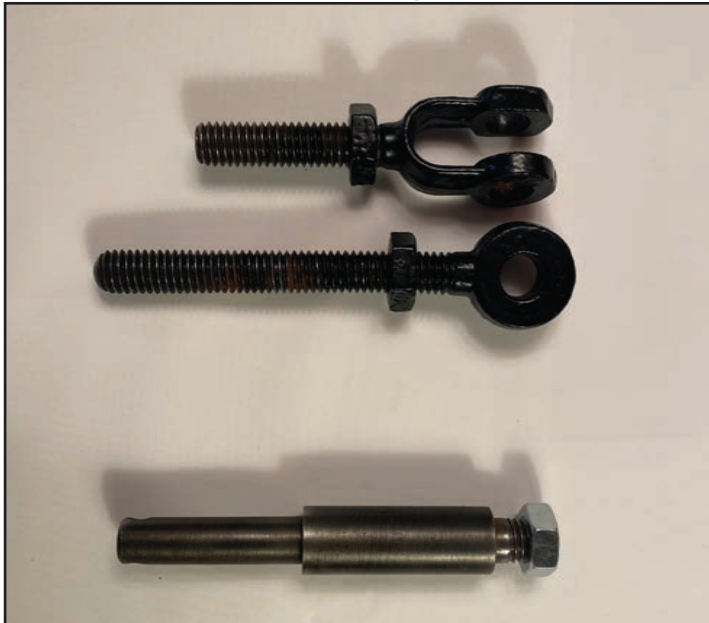
Above, a Fairmont yoke and eye bolt with original 12 TPI jam nuts, and below a NOS pivot stud with a modern 13 TPI half nut

end wrench, rather than 13/16" wrench. These USS course thread half nuts for use on the pivot studs are readily available at most hardware stores. Rather than placing loosened nuts in a box, it is a judicious practice to reattach these nuts to the corresponding parts after disassem-

bly as original Fairmont jam and half nuts of both thread patterns are very similar in appearance. New 12 TPI jam nuts used on Fairmont motorcars are not widely available. Unintentional cross threading of these nuts could ruin valuable brake components. Exactly why Fairmont chose to use different 1/2" thread types on brake systems may be lost to history.

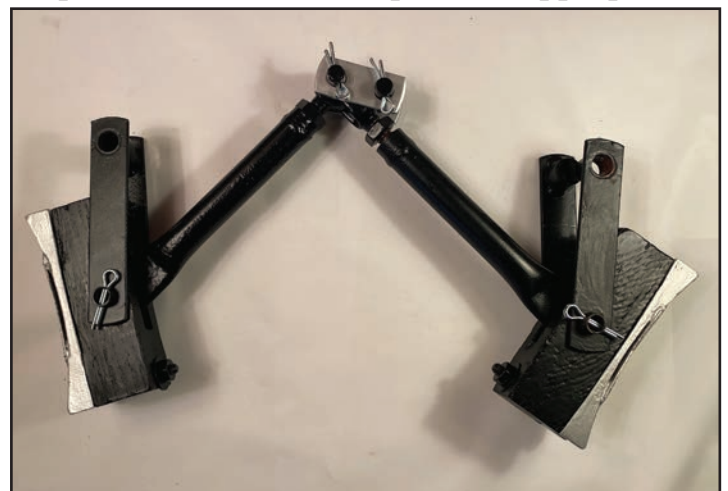
A nearly complete brake rehabilitation. These brakes will not only work well and are ready to bring your ride safely to a stop, but also look great when finished.

With a complete rehabilitation, I typically sandblast all steel brake components, except brake liners, blocks, and threaded areas. Immediately after sandblasting metal parts, I will brush on a coat of red oxide primer, followed later by a brush applied second coat of chosen color, and a third sprayed coat. I typically only paint exposed threads with one or two coats of light spray, so as to not gum threads. I prefer oil-based paints if available. There are many good paint protocols, but this is what I have found to be successful for long term corrosion prevention.

At this point, reassembly should be straight forward. I believe cotter pins should be replaced on every rebuild and most Fairmont motorcars utilize a standard 3/16” X 1” cotter pin. Be aware that using cotter pins longer than 1” risks unintentional shunting of rails through the braking system and wheels when brakes are applied. The final step in the process is to adjust the brakes as appropriate, tighten jam nuts against the toggle arms, and visually inspect the finished brake assemblies, making sure all cotter pins are inserted and spread as appropriate.
