# COOL TOOLS

Several members have submitted interesting Tool related articles, so they are combined, here. - Editor

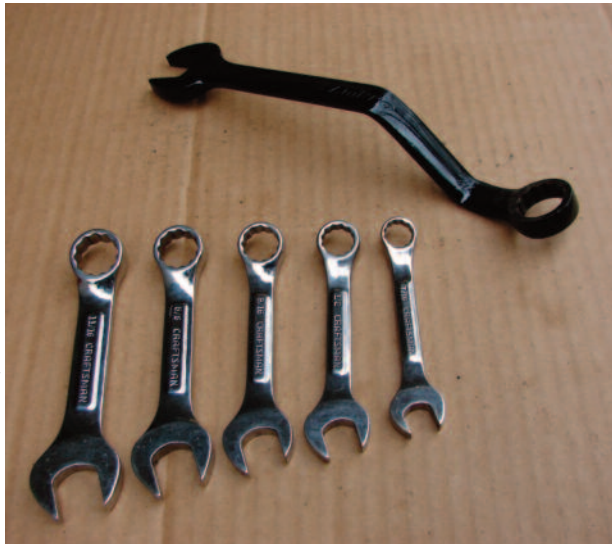
photo by Dick Ray

The big wrench shown in the picture, called a Reynolds Wrench allows a person to hold the head of those difficult wheel mounting bolts inside the wheel. The bent wrench allows access from the outside by inserting the wrench through the holes between the spokes. Then the wrench is held from turning by the spokes themselves. If you choose to bend one yourself it may take some experimenting. The shape is different for cars with flat fenders such as a MT-14 than it is for round-fender cars, like the MT-19.
