# MT-19 CLUTCH ROD BREAKAGE:

## A SOLUTION BY TOM SOPCHAK

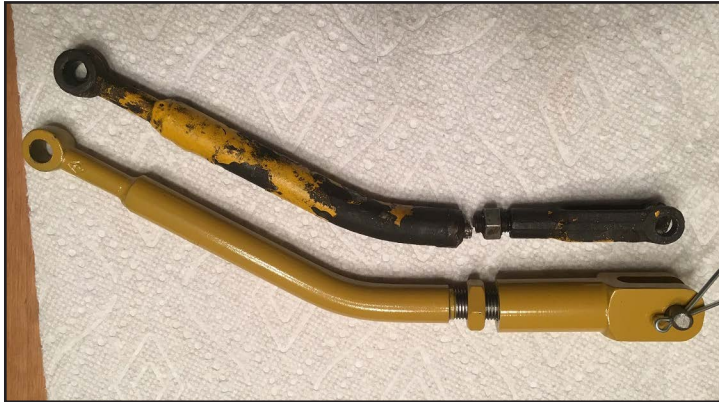
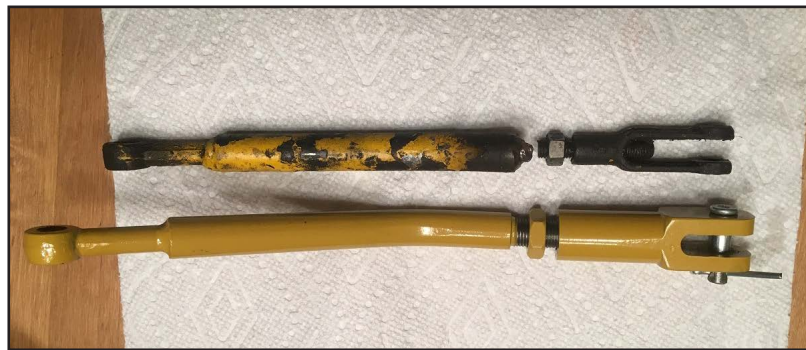
If you look at the photo you can see a stark difference between the old and newly redesign clutch rods. From the eye-let end to the area where the threads start the two clutch rods

are dimensionally the same. The differences start at the threads. The O.E. (original equipment) rod uses

cess used to attach the treaded rod makes it brittle and prone to break at the weld. The threads are 3/8" X 16 threads per inch. The aftermarket clutch rod does not use a separate piece for the threaded area. The threaded area is machined to size and a thread die is used to form the threads. The threads on the aftermarket clutch rod are 1/2" x 20 threads per inch. The larger diameter, plus the fine threads on the aftermarket clutch rod have a higher shear strength than the coarse threads on the O.E. rod making it significantly stronger.

for its threads. The threaded rod is a high carbon material and should not be welded. The welding pro-

I happened to be at Ed Lee's shop in Delaware rebuilding a transmission for an MT14 when I noticed what looked like brand new clutch rods for MT19's. When I asked him about them he explained that there is a design flaw in them and that they are prone to breaking. This was news to me but since I'm so new to the hobby I bought one to have as a spare for my MT19.
