Brake Shaft Wear

Page 14 • THE SETOFF • November/December 2000

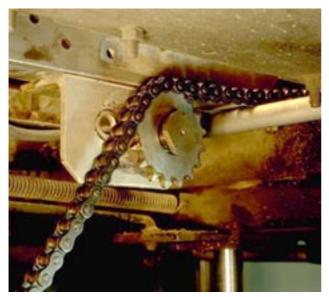
MT19 chain path showing chain slack, which can lead to brake shaft wear and failure.

Another accident waiting to happen involves the brake shafts on MT14 and MT19 chain-drive cars. The brake shaft is made from 7/8" OD steel tubing with a 1/16" wall. The drive chain is guided up and over the brake shaft by the idler sprocket. Poor maintenance, excessive chain slack, and/or elongation of the chain due to wear, allows the chain to rub on the brake shaft. See the following photo. We have had

After reinstalling the brake shaft, be sure you eliminate the original problem causing the shaft wear. If your chain has stretched, put on a new chain. Maintain the correct chain tension. Most chain manufacturers recommend chain slack to be 4% of the span. One even suggests 2% slack for variable speed or reversing drives. You don't want it too tight, but too loose will cut the brake shaft lever.

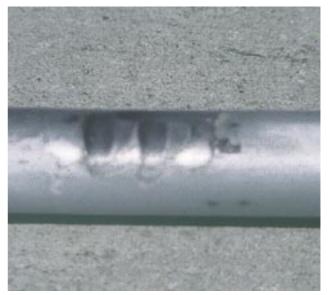
Brake shaft worn nearly half way through. Note twist and bend in shaft from brake application.

incidents in which the brake shaft tubing is cut through by the chain, to the point that during brake application the shaft shears in two. The resulting loss of brake effort provides a challenging problem to the operator! Hopefully there is dry track and plenty of distance between motorcars.

The easiest way to check for brake shaft wear is to feel with your finger the top of the brake shaft, just below the chain. The shaft should be round and smooth, but if you feel any roughness or wear, remove the drive chain, wipe the grease off the brake shaft, and observe the shaft surface. Remove the housing seat assembly (engine cover) and look down onto the brake shaft. If the original paint is intact you are home free. If it is worn you will need to determine to what extent. In my opinion, if it has cut through the wall of the shaft, and you can see a hole into the tube it must be repaired.

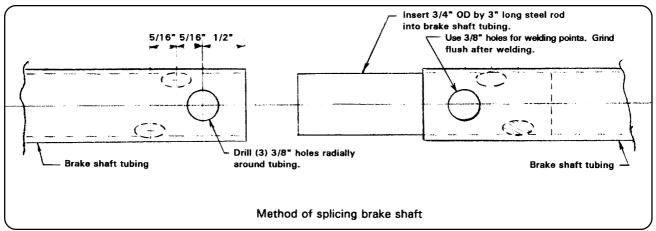
Method of splicing brake shaft.

How do you repair the shaft? I've used the following method to splice brake shafts. See the attached drawing. First note the position of the brake arm ends. Once you cut the shaft in two, you will need to reassemble with the brake arms in the same position. I place the entire brake shaft on a flat surface, with brake end arms also flat on the floor. I then use a protractor to measure the angle of the brake lever plate from the flat surface. I actually cut a small block of wood to use as a guide to maintain this angle. Then cut the shaft in two at the chain wear site. Drill three 3/8" diameter holes in each tube end, to be used as welding points. Drill these holes radially around the tube, the first hole 1/2" in, the second 13/16", and the third 1-1/8" in from the tube end. Use a 3/4" hand reamer to prepare the tubing ends. Ream slightly over 1-1/2" deep so that a 3/4" OD by 3" long piece of steel rod can be inserted halfway into each shaft end. Align the shaft so that brake arm ends are positioned correctly. Weld the rod to the shaft at each hole. Then grind flush with the outside of the shaft. This is essentially the same method that Fairmont uses to weld the brake shaft ends to the brake shaft.
