## EDUCATION, NOT LEGISLATION

### SPRING FROGS

By Dick Ray

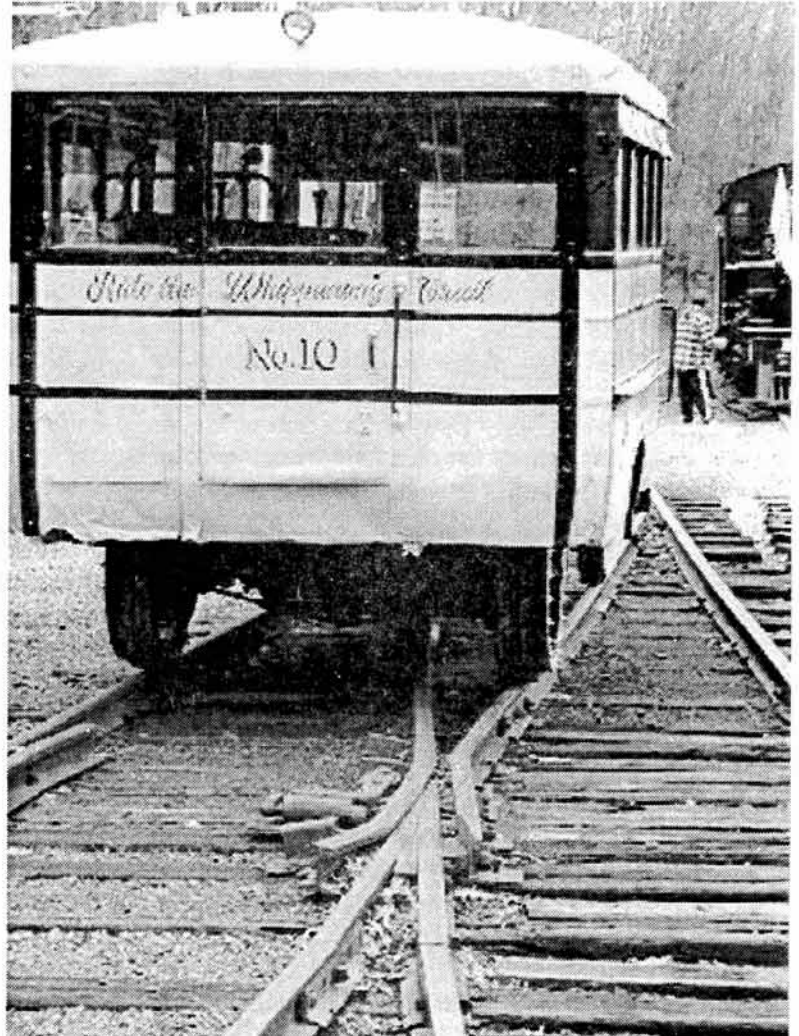
Look closely at the frog behind the railbus. If the bus moves backward there is seemingly no flangeway for his right rear wheel. If the flange follows the one flangeway you can see, he will be derailed. The close-up photo of the frog shows that there is a spring-loading mechanism holding the needed flangeway closed. The railbus and typical railroad cars are heavy enough to overcome the spring tension and so provide a flangeway through the frog.

The spring frog is intended to provide a smooth route through the main line or straight route. The railbus is on the diverging route. The danger to a motorcar is present going either direction on the diverging route, but the straight route is safe.

The railbus is a 1918 White, and is located at the Whippany Railroad Museum at Whippany, New Jersey. The rail in the vicinity of the spring frog bears the dates 1919 and 1923. It is not known if this is the original rail, but the bus went into service here in 1918 on the Morris & Essex Railroad. Some of the ties do not have tie plates, and the rail appears to be no larger than 70-pound.

Our motorcars are typically not heavy enough to pry the flangeway open and so will bounce up and over the frog. If the car is going faster than a walk, the guardrail shown on the left rail may not be enough to contain our flange, and a

derailment may occur. It has happened more than once, but should never happen again. Remember that you do not just fall onto the ties. You fall onto a switch which can damage your rear pulley or sprocket. In addition the rails can bring you to a very sudden stop and cause you to fall out of the car.
