B48G CLUTCH OVERHAUL

BY WAYNE PARSONS

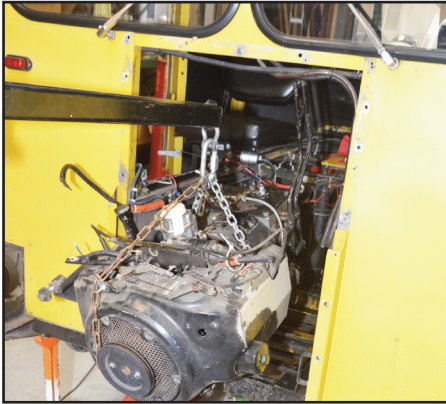
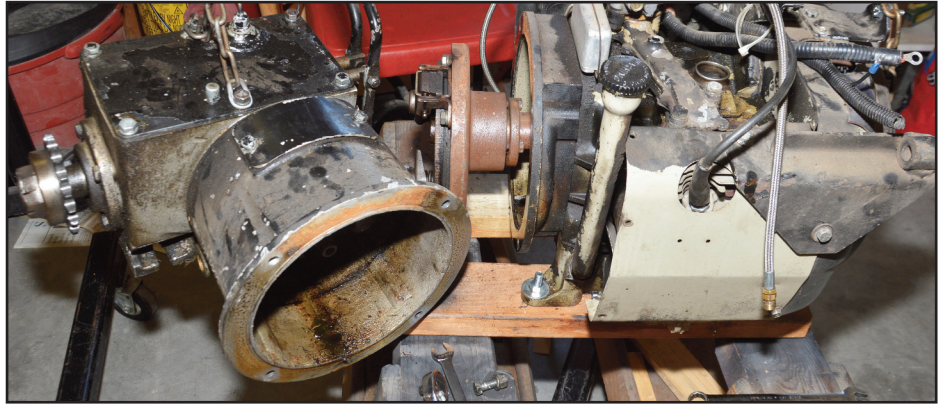
Before starting, take some pictures for reference. Lift out the motor and transmission as one unit. *Center below left:* The driven plate, between the pressure plate and flywheel, is covered with oil. Oil has leaked out of the transmission and along the bevel pinion. The driven plate material can't get a grip now because of wear and the oil. *Below center:* With the clutch removed the back of the motor is exposed. Check for leaks and clean the area. Leave the bushing assembly on the crankshaft. *Center right:* The worn pressure plate (top) and driven plate. *Below left:* The clutch is back from the shop with newly machined surfaces and new friction material. A new 6303-2RS bearing will be pressed into the flywheel center and a new throwout bearing used. *Below right:* Use the bevel pinion to line up the driven plate while inserting and tightening down the pressure plate bolts.

However, over time, oil will get past the bearing seal, travel out the pinion carrier assembly, and contaminate the clutch. The solution is a new pinion carrier with a rubber seal. Ed Lee in Chesapeake City, MD, makes a custom pinion carrier (below left) that has room for a nitrile rubber (NBR) type ADL seal (23 x 40 x 06). The original bevel pinion gets machined down slightly (next to the retaining ring) to make room for, and mate up with, the NBR seal.
